ALL OPERATORS MESSAGE

Ref. AOM: 42/72/2016/11 issue 2

Aircraft models: ATR42 and ATR72

SUBJECT: Passenger door forward handrail quick release pin

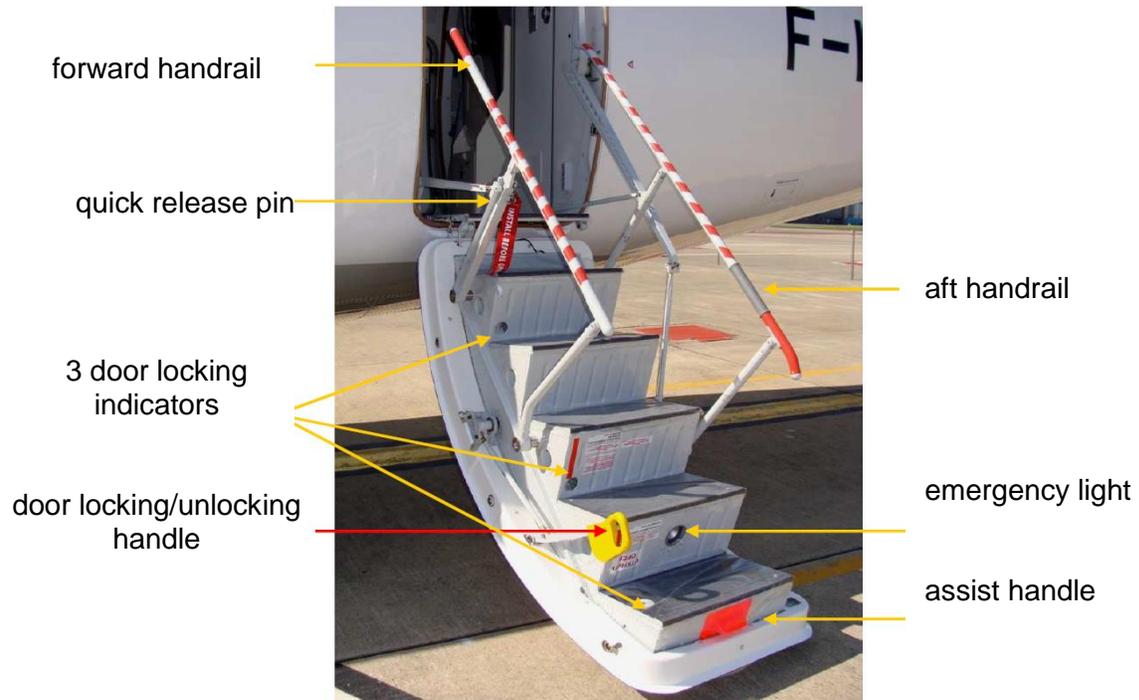
The passenger door located at the rear left-hand side of the aircraft is an outward opening type door. Attached to the integrated stair structure is an aft folding handrail which, by means of a linkage to the fuselage structure automatically deploys when the door is opened. On ATR aircraft having embodied specific modification (refer to effectivity paragraph), a second adjustable forward handrail deploys automatically when opening the door, providing that the quick release pin is in “ground” normal position (refer to Appendix 1 Picture 1).

Picture 1: forward handrail in deployed position

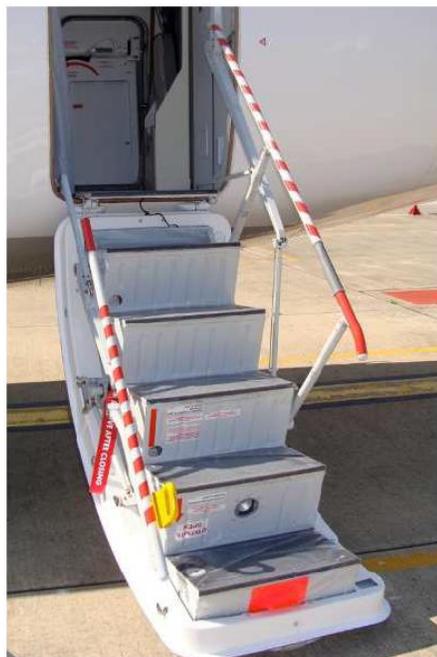
If the quick release pin fails to perform its intended function (or if it is not installed in “ground” position), the forward handrail will fall into its folded position (refer to Appendix 1 Picture 2).

When a passenger leans on the handrail, the handrail collapse may lead the passenger to fall off the stairs, possibly resulting in injury.

Picture 2: forward handrail in folded position

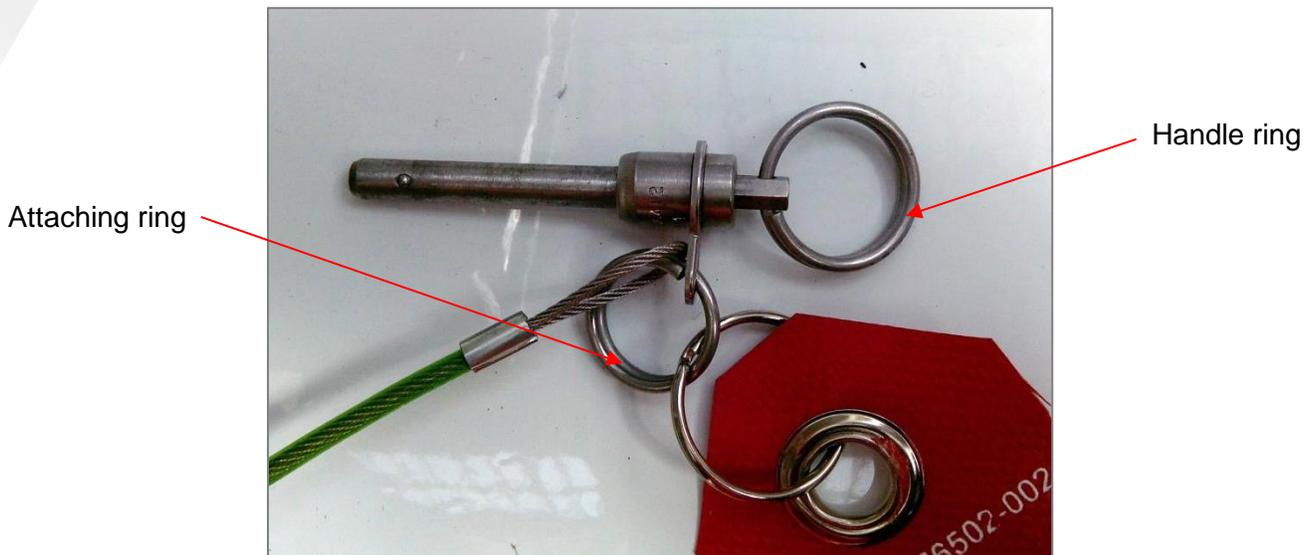
Picture 3: current quick release pin P/N MS17990C412 and its warning streamer correct installation

- 1) The operator to replace at the first opportunity, the current quick release pin P/N MS17990C412 by a new pin P/N MS17984C412.
- 2) The Operator crew members to make sure that the quick release pin is correctly locked,
- 3) The line maintenance staff to check that the quick release pin and red warning streamer are correctly installed. For the current quick release pin P/N MS17990C412, the red warning streamer has to be attached to the attaching ring and not to the handle ring (refer to Appendix 1 picture 3).

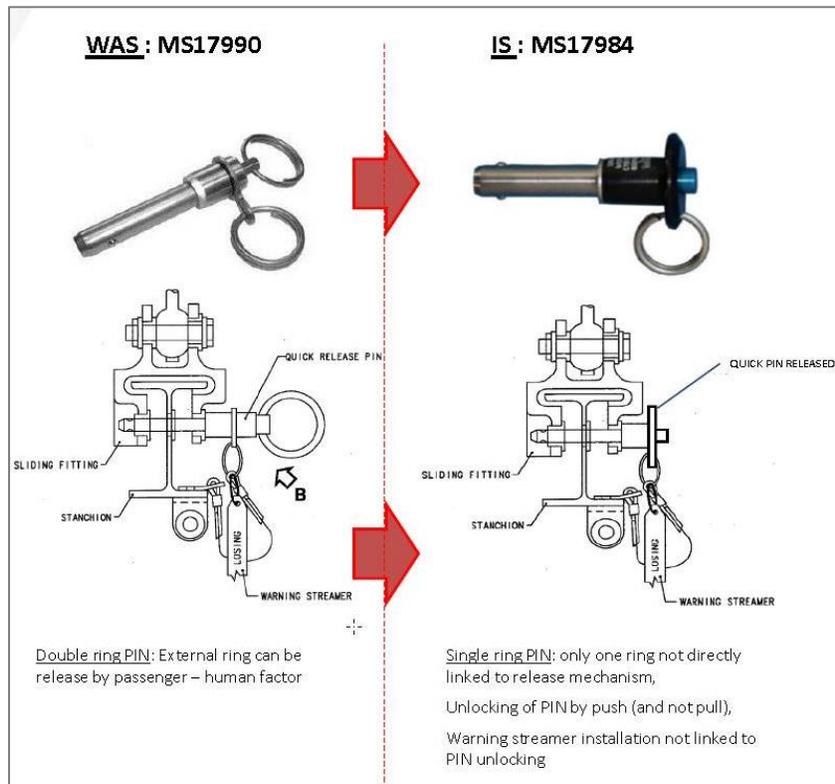
Picture 4: Current P/N MS17990C412 and New P/N MS17984C412 to be installed

- Operator cabin crew members to follow the Cabin Crew Operating Manual procedure, to check that the quick release pin is in good condition, and to make sure that, while opening the door prior to each boarding or disembarkation, the quick release pin is correctly locked.
- Line maintenance staff to check that for the quick release pin MS17990C412 (Double ring), and the red warning streamer are correctly installed at the attaching ring and not at the handle ring (refer to Appendix 1 picture 3).
- Operator, to replace at the first opportunity, the current quick release pin P/N MS17990C412 by the new interchangeable one P/N MS17984C412 (refer to Appendix 1 picture 4).

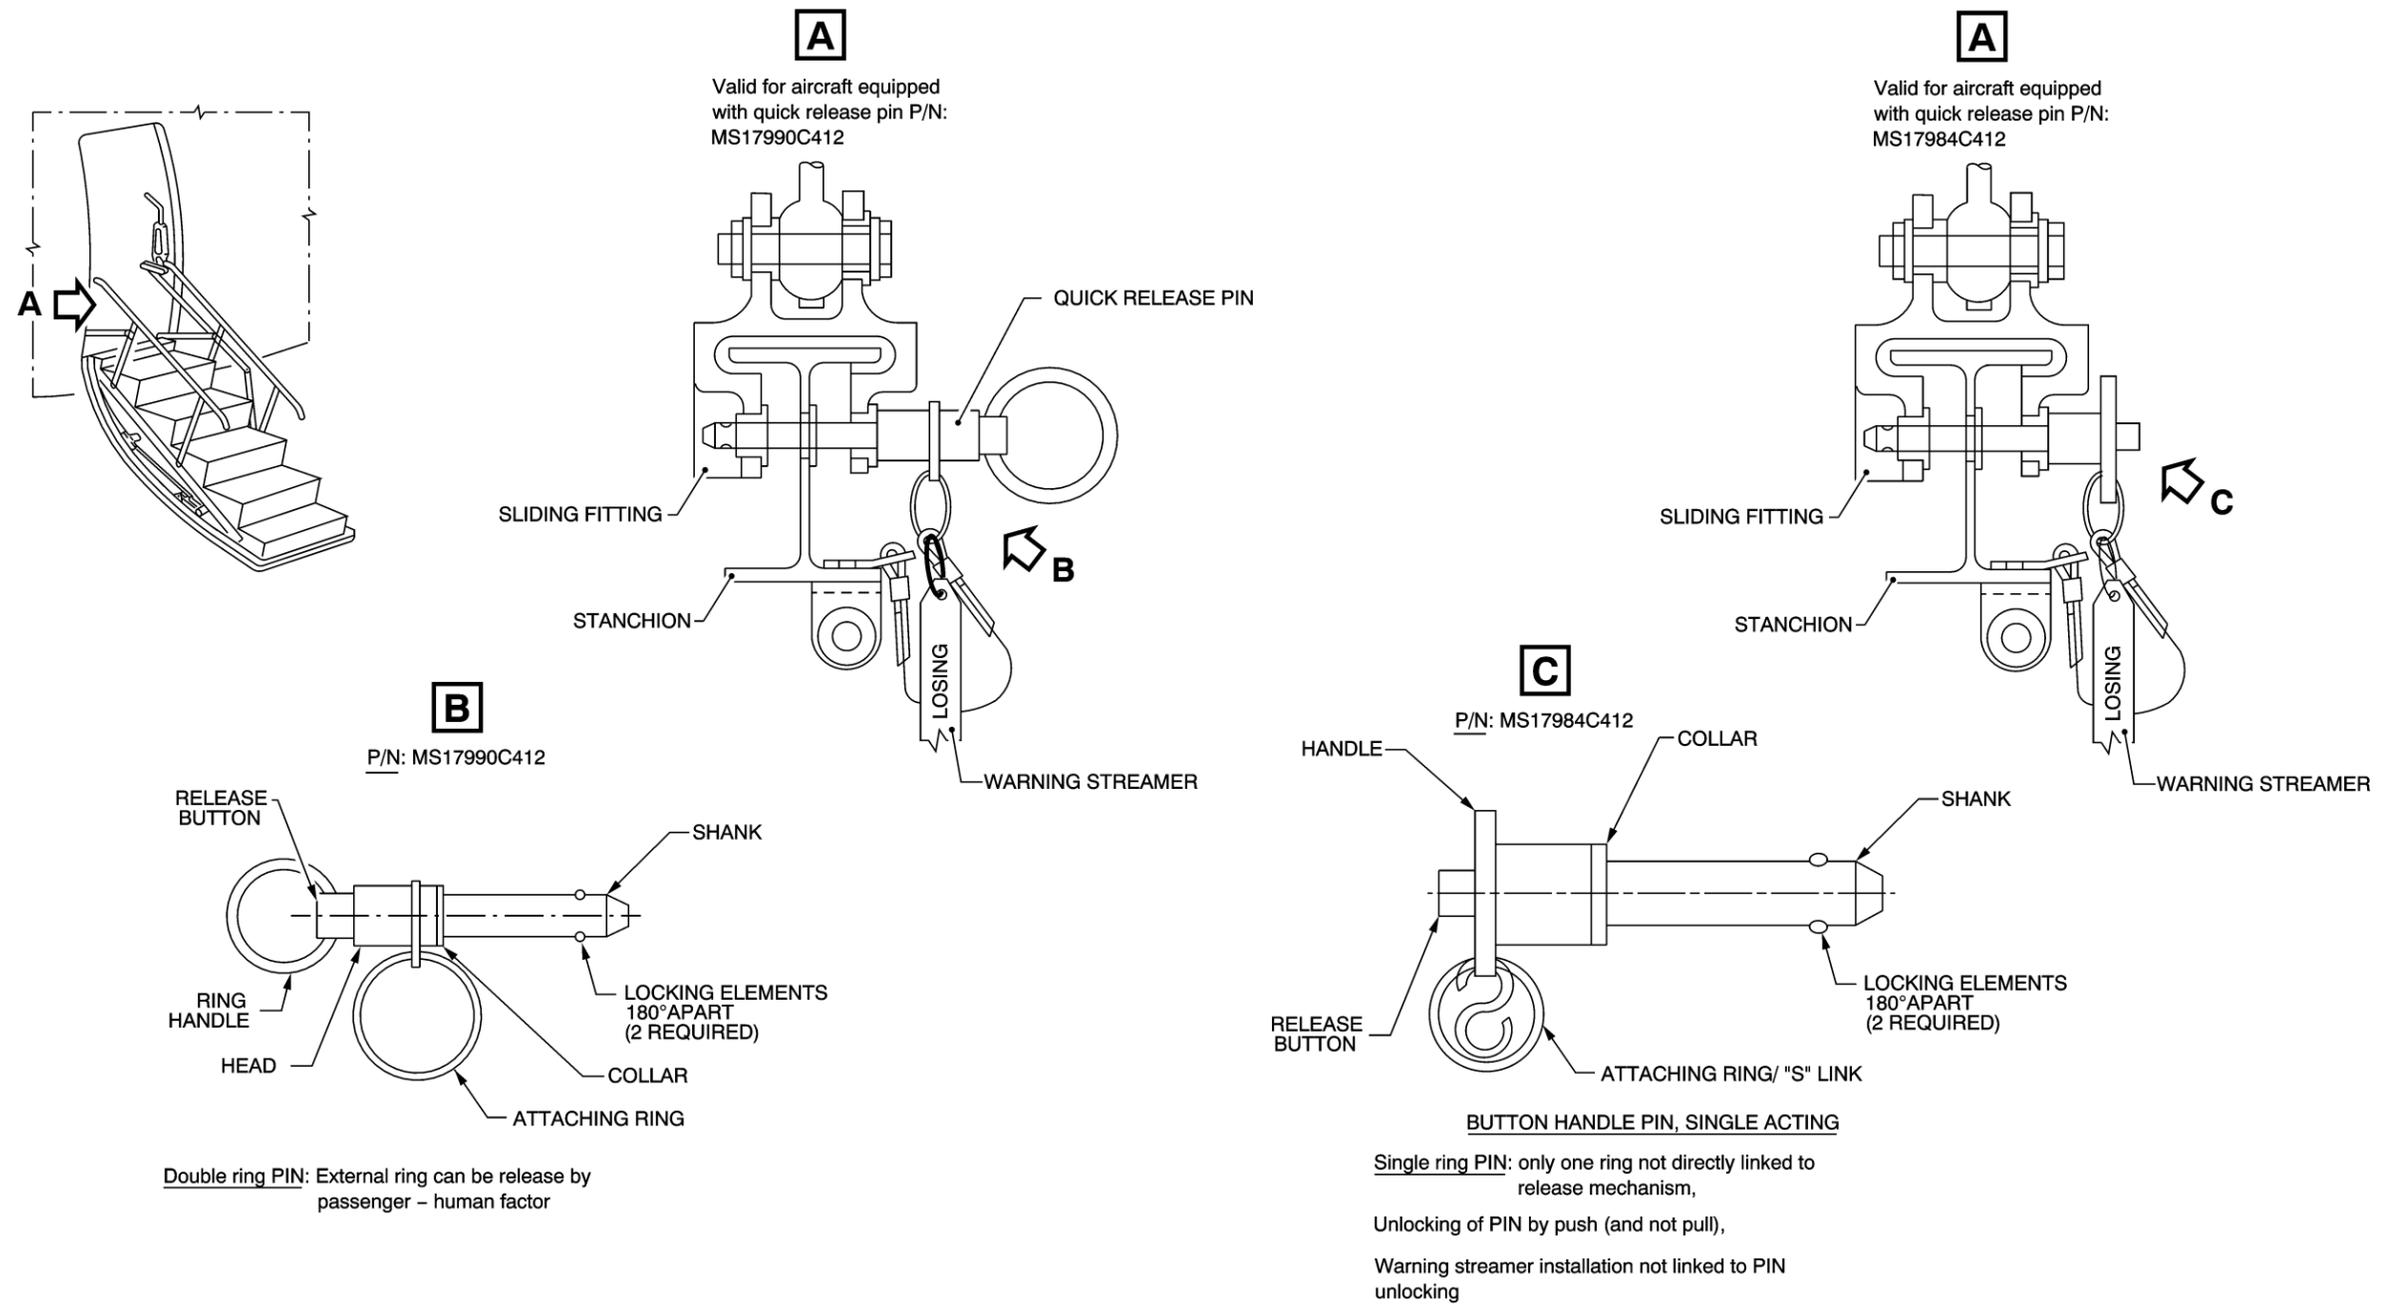
Figure 1

Also, the warning streamer, usually fixed to the attaching ring, was found incorrectly installed to the ring handle of pin P/N MS17990C412: in this case, if inadvertently the streamer is dragged away it can pull out the pin allowing the sliding fitting to move and the handrail to get free.

Operator maintenance staffs are also recommended to pay attention that, the quick release pin and/or warning streamer are correctly installed at attaching ring and not at ring handle specifically for pin P/N MS17990C412 as for new interchangeable pin P/N MS17984C412 warning streamer installation is not linked to pin unlocking (refer to AMM (JIC) 52-11-00 OAC 10000 and to figure 1 for clarification).

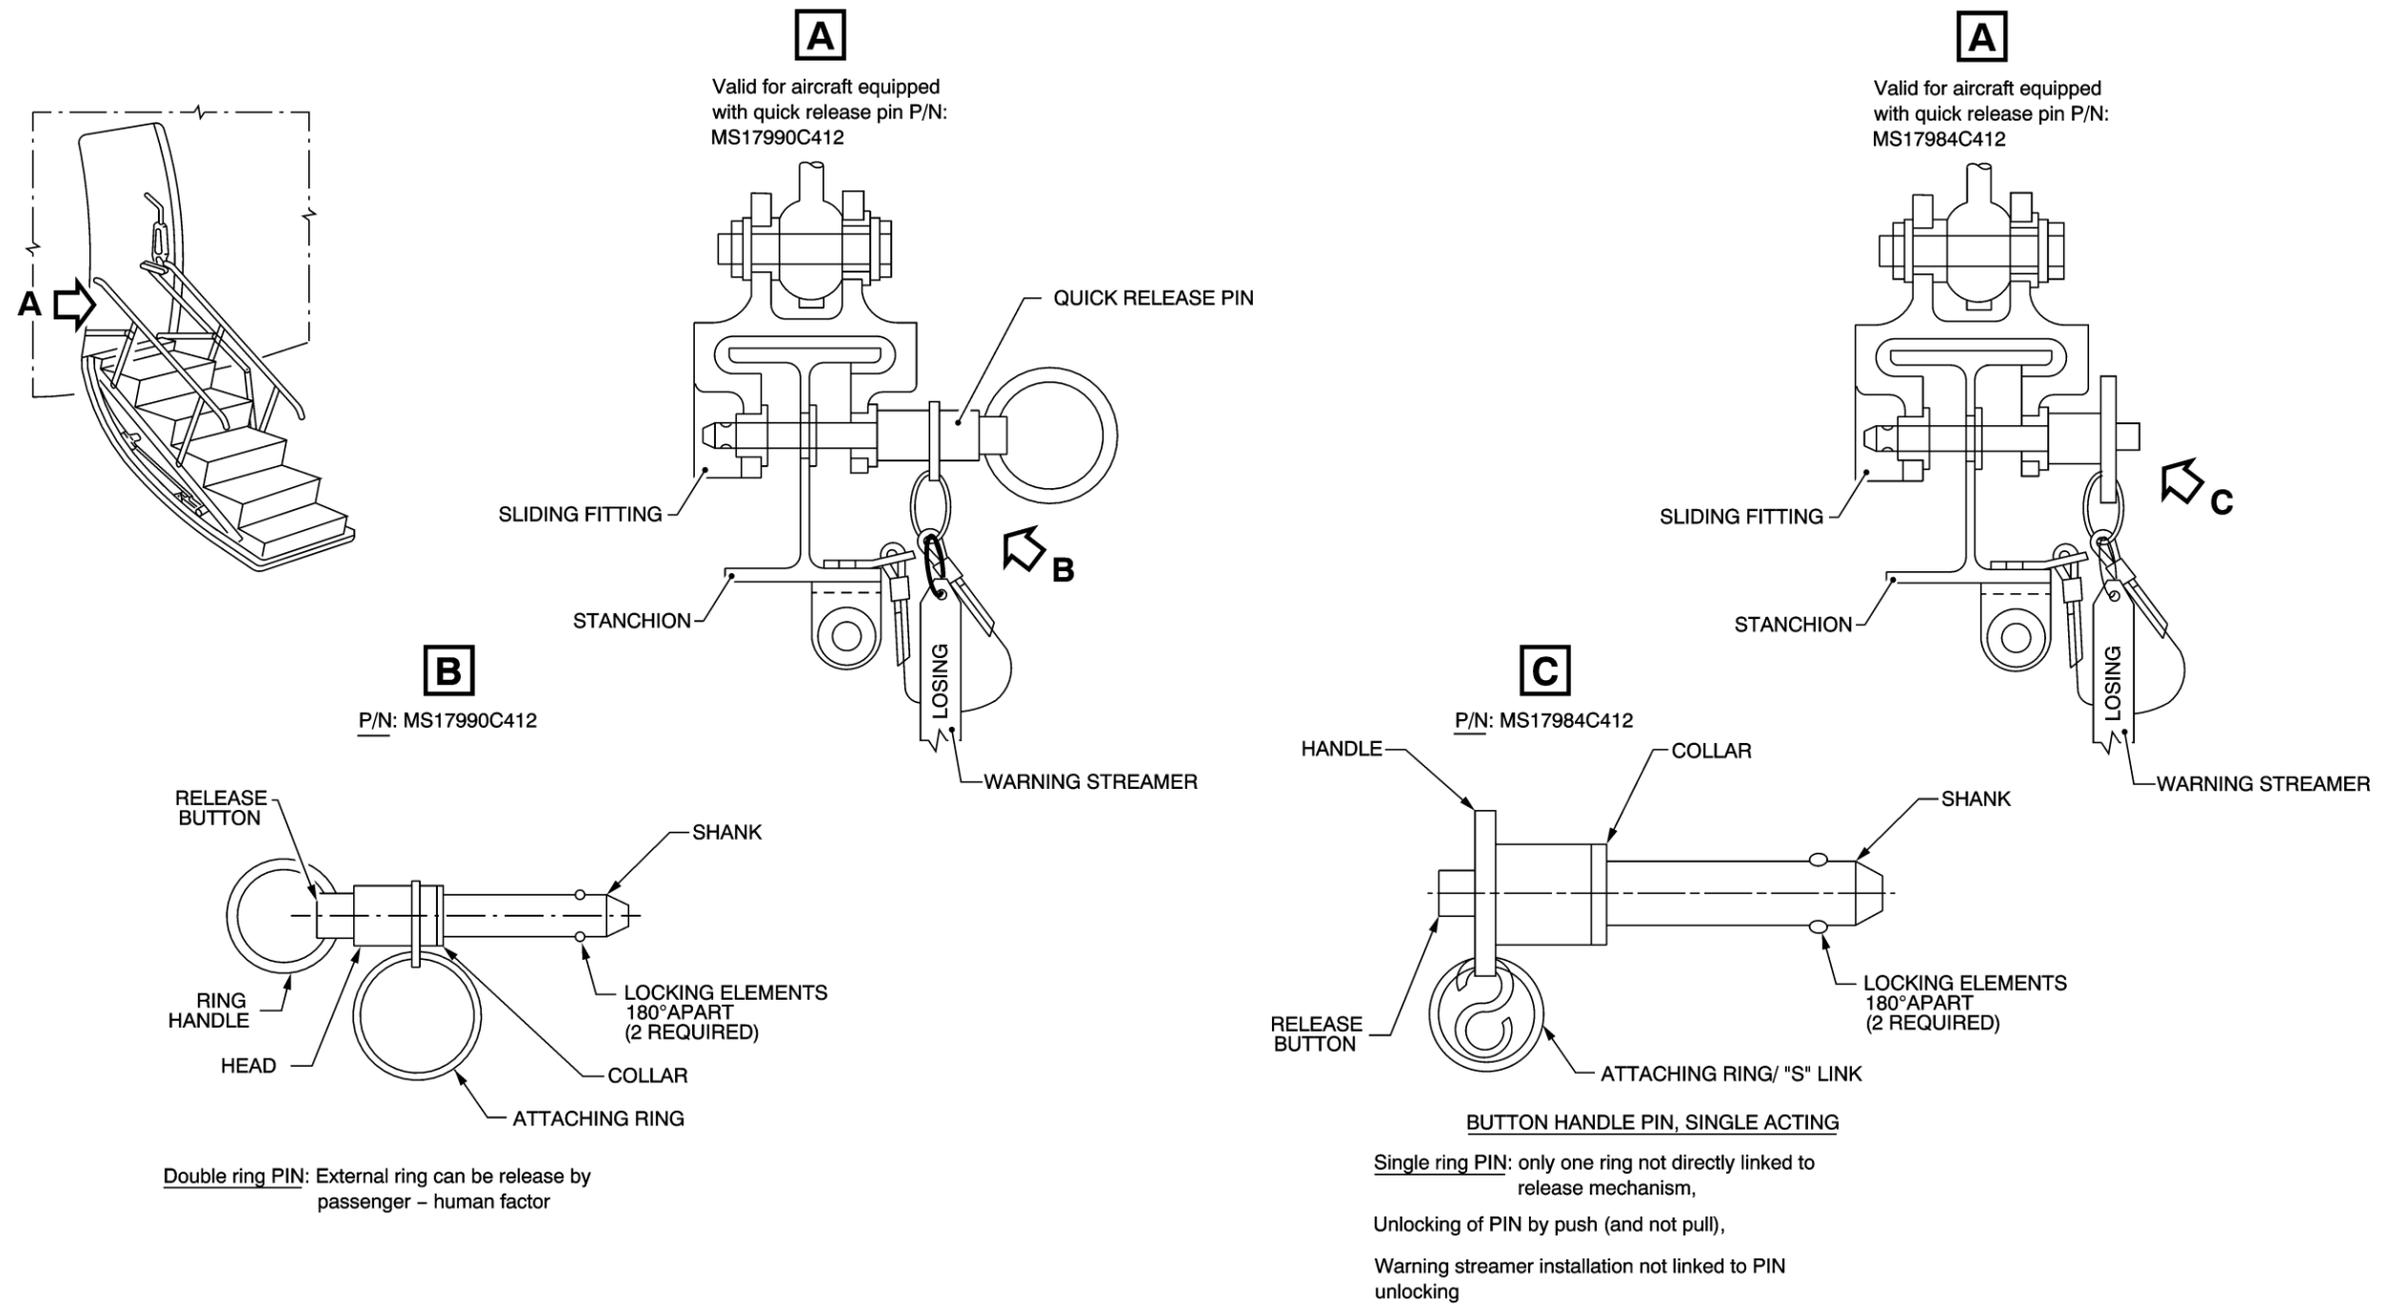
Figure 1

Also, the warning streamer, usually fixed to the attaching ring, was found incorrectly installed to the ring handle of pin P/N MS17990C412: in this case, if inadvertently the streamer is dragged away it can pull out the pin allowing the sliding fitting to move and the handrail to get free.

Operator maintenance staffs are also recommended to pay attention that, the quick release pin and/or warning streamer are correctly installed at attaching ring and not at ring handle specifically for pin P/N MS17990C412 as for new interchangeable pin P/N MS17984C412 warning streamer installation is not linked to pin unlocking (refer to AMM (JIC) 52-11-00 OAC 10000 and figure 1 for clarification).
