WORLDWIDE  
**FLIGHT SAFETY  
CONFERENCE**

**ATR**  
PROPELLING THE NEXT CONNECTION

# Engine Fire Warning During Steep Slope Descent In Landing Configuration

Publication of OEB n°32  
AOM: 42/72/2017/07 issue 1

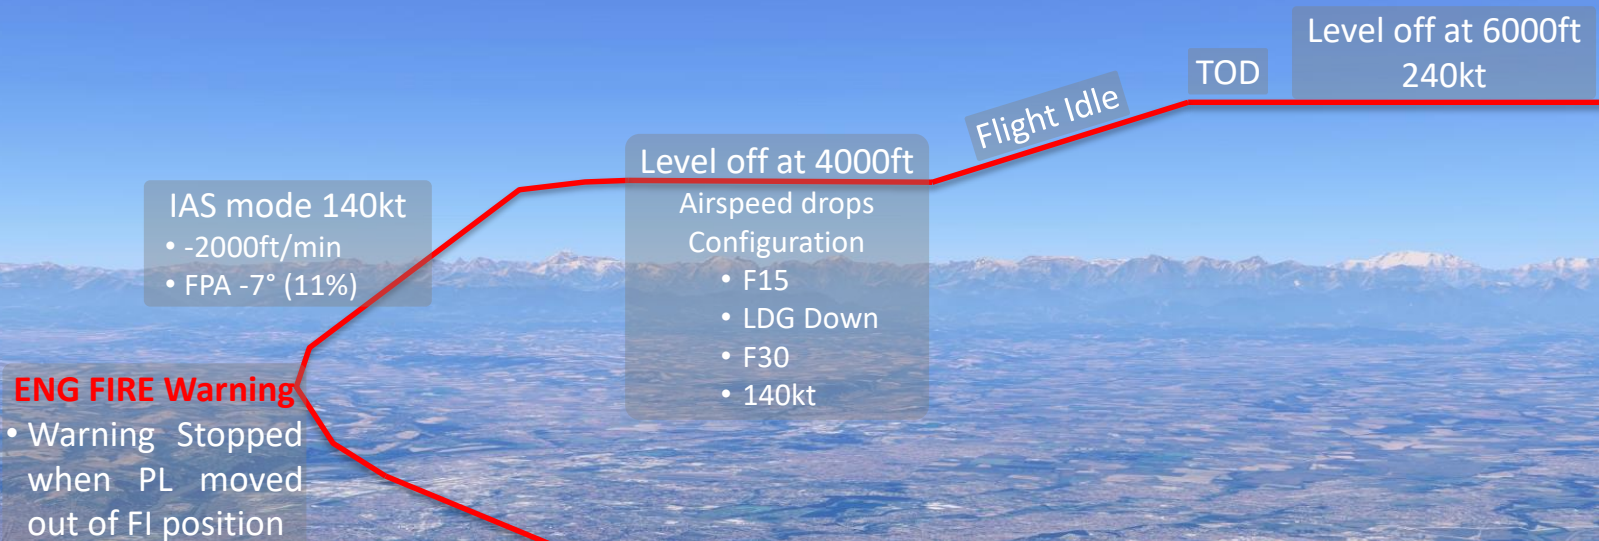
# Typical Event

- **17 Engine Fire Warning events reviewed in similar conditions since 2015**
  - **During steep slope descent at low speed**
    - Around 130 kt to final approach speed
    - Descent Flight Path Angle  $>5.5^\circ$  (9.6%) and Descent Rate  $>2000\text{ft}/\text{min}$
    - Pitch attitude  $> -7^\circ$
  - **In landing configuration**
    - Gear Down, Flaps 30 or 35 set at high altitude (above 4000ft)
  - **Power Levers maintained at Flight Idle: Average 2min in FI**
  - **No traces of Fire**

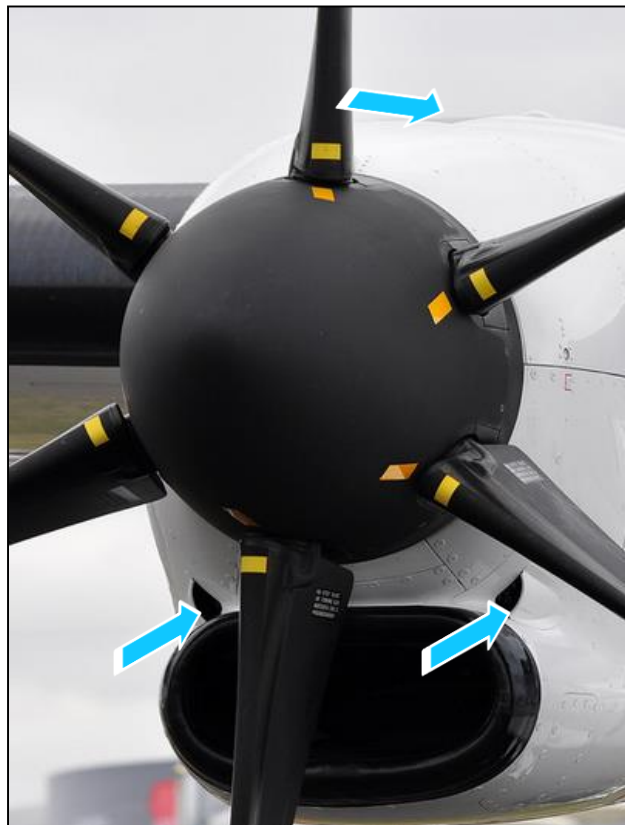
# Nacelle Ventilation

In such conditions, the engine operation is reduced and the engine temperature may reach the engine fire detection threshold triggering the ENG FIRE warning. In some of these situations, events associated with the above conditions, the ENG FIRE warning stopped when the Power Levers were advanced above Flight Idle position.

▶ PL 1+2 ..... ADJUST ABOVE 10% TQ  
*TQ increase improves the nacelle ventilation*

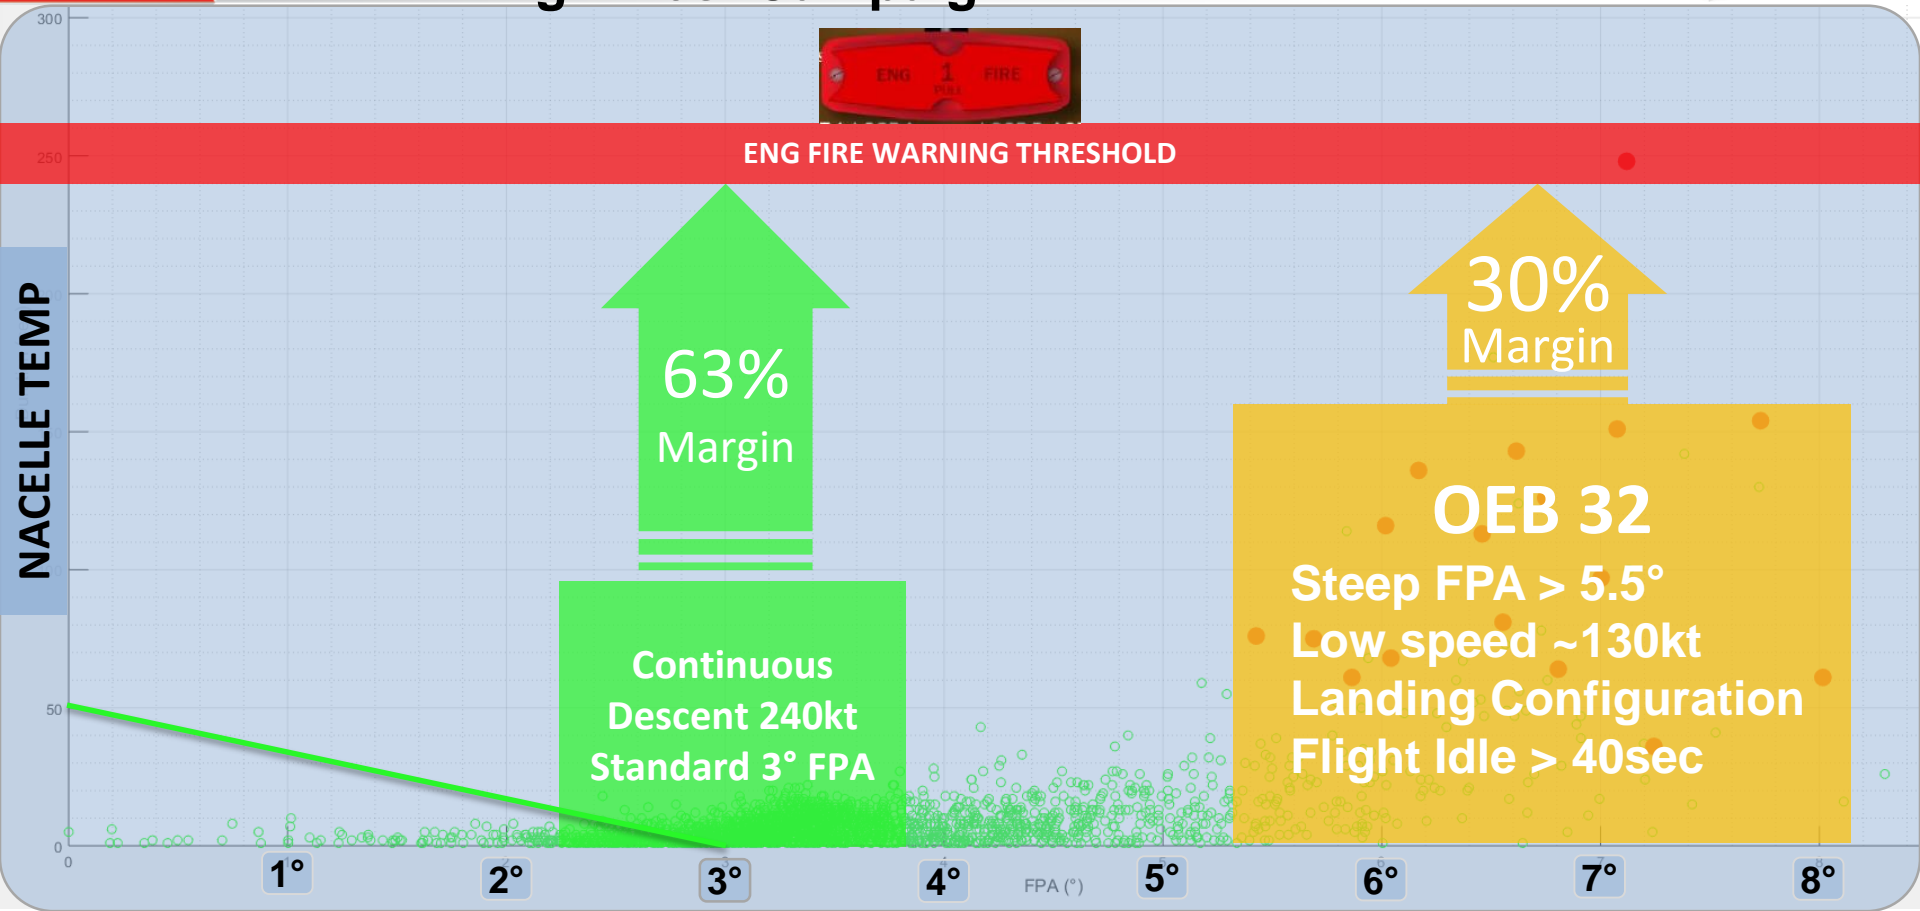
# Flight Test Campaign

ENG FIRE WARNING THRESHOLD

63%  
Margin

30%  
Margin

OEB 32  
Steep FPA > 5.5°  
Low speed ~130kt  
Landing Configuration  
Flight Idle > 40sec
