WORLDWIDE  
**FLIGHT SAFETY  
CONFERENCE**

**ATR**  
PROPELLING THE NEXT CONNECTION

# Engine Fire Warning During Steep Slope Descent In Landing Configuration

Publication of OEB n°32  
AOM: 42/72/2017/07 issue 1

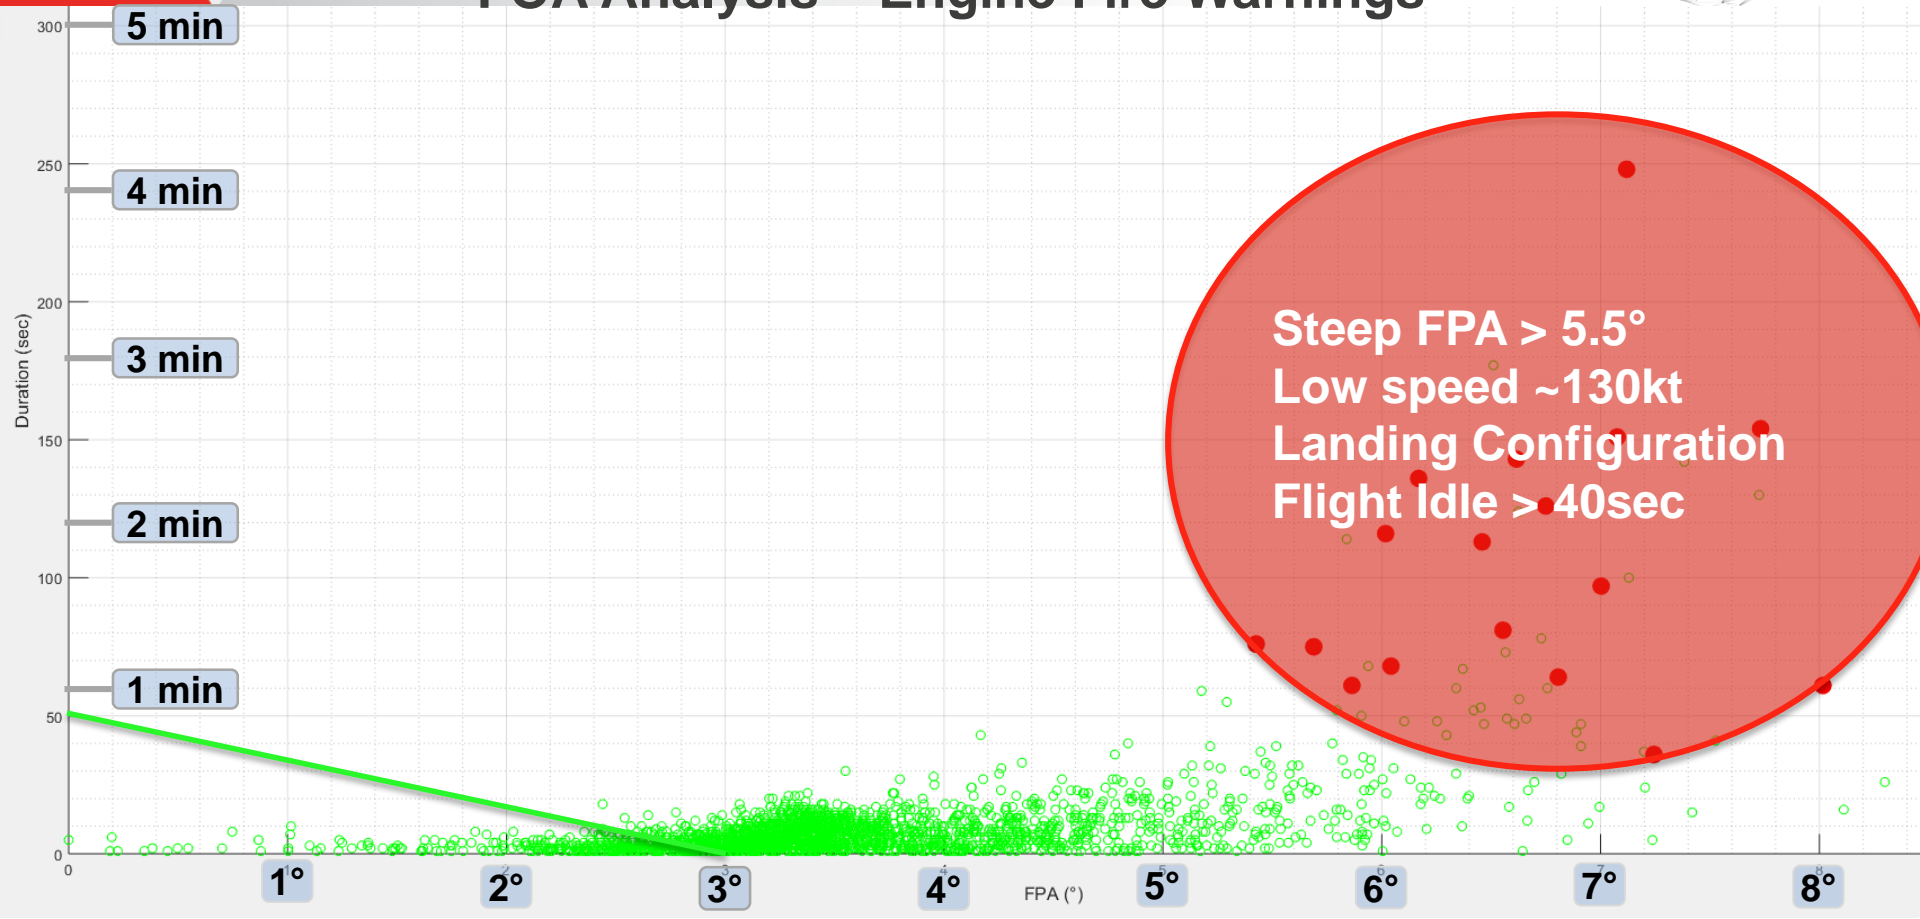
# FOA Analysis – Engine Fire Warnings

- **17 Engine Fire Warning events reviewed in similar conditions since 2015**
  - **During steep slope descent at low speed**
    - Around 130 kt to final approach speed
    - Descent Flight Path Angle  $>5.5^\circ$  (9.6%) and Descent Rate  $>2000\text{ft}/\text{min}$
    - Pitch attitude  $> -7^\circ$
  - **In landing configuration**
    - Gear Down, Flaps 30 or 35 set at high altitude (above 4000ft)
  - **Power Levers maintained at Flight Idle: Average 2min in FI**
  - **No traces of Fire**

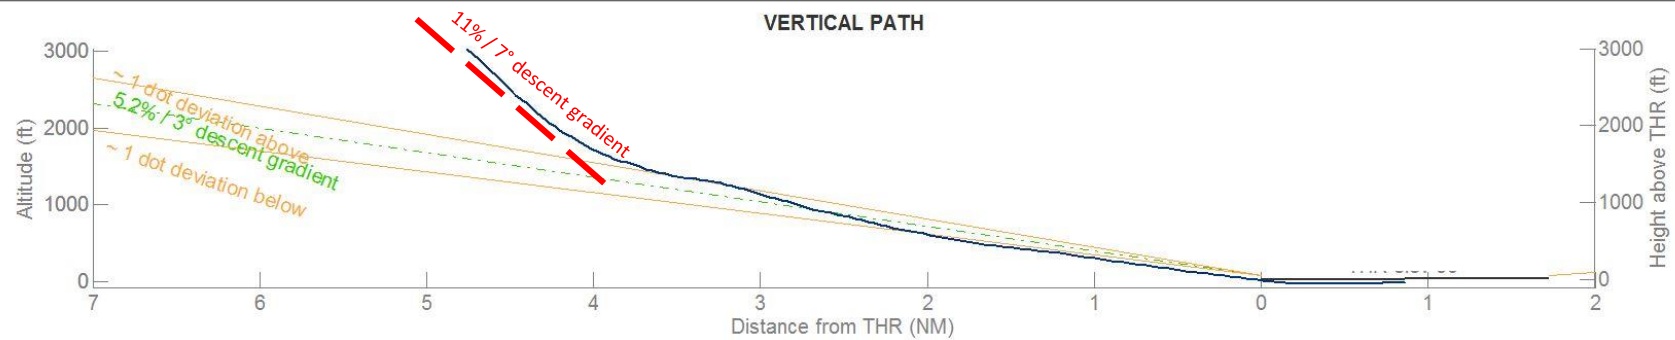
### VERTICAL PATH

- Unpredictable Vertical Flight Path
- Unstabilised Aircraft Energy State
- No standard stabilisation gates for PM
- High Flight Crew workload to cope with **EMERGENCY**

- -2000ft/min
- FPA -7° (11%)

ENG FIRE Warning

- Warning Stop
- when PL moved

- Continuous Descent from Top Of Descent
- Standard 3° FPA
- Predetermined vertical flight path
- Stabilised approach: energy & gates
- Less workload to cope with **EMERGENCY**
